Drinking Water Quality Management Plan

2022.0164

Winton Shire Council

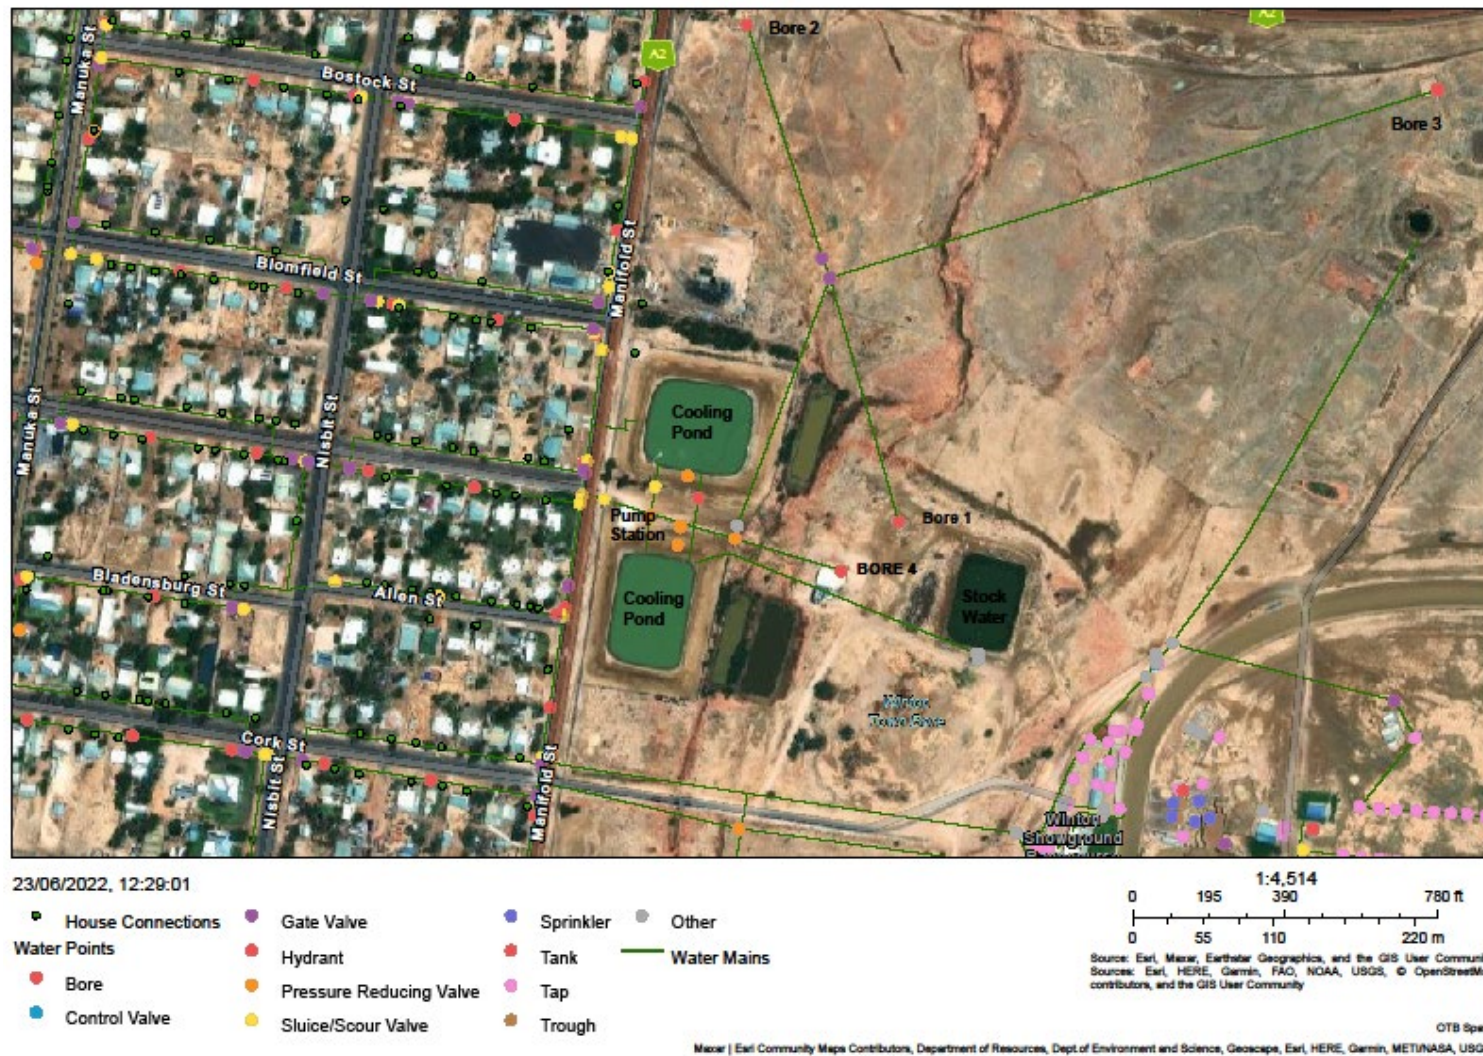
Figure 3 Location of Bores and Pump Station

The physical location of the bores and pump station are shown in the following figure – the GIS mapping is available on the council website at <https://winton.maps.arcgis.com/home/index.html> and can be interrogated by any member of the public (select inground assets).

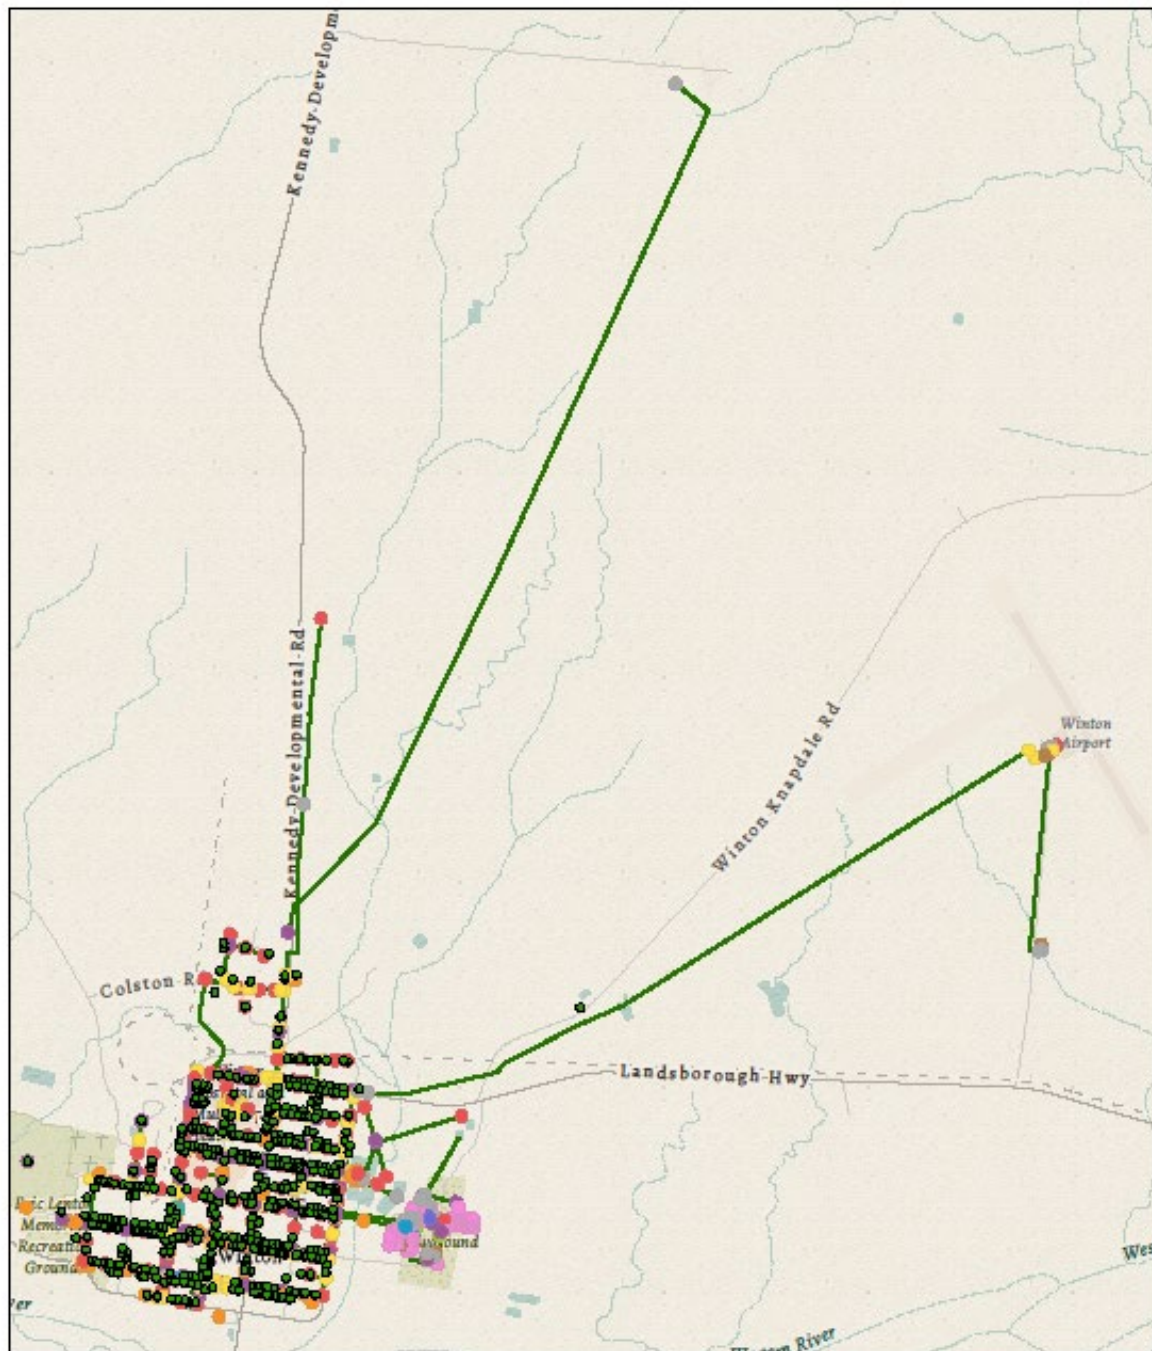
Figure 5 Full bore to tap schematic

- House Connections
- Water Points
 - Bore
 - Control Valve
 - Controller
 - Gate Valve
 - Hydrant
 - Pressure Reducing Valve
 - Sluice/Scour Valve
 - Sprinkler
 - Tank
 - Tap
 - Trough
 - Water Tower
 - Other
- Water Mains
